Memorandum

Subject: PSA Inspections and Recommendations

Figure 1
PSA Inspections Wallace Silversmith Layout
San German Groundwater Contamination Site
San German, Puerto Rico

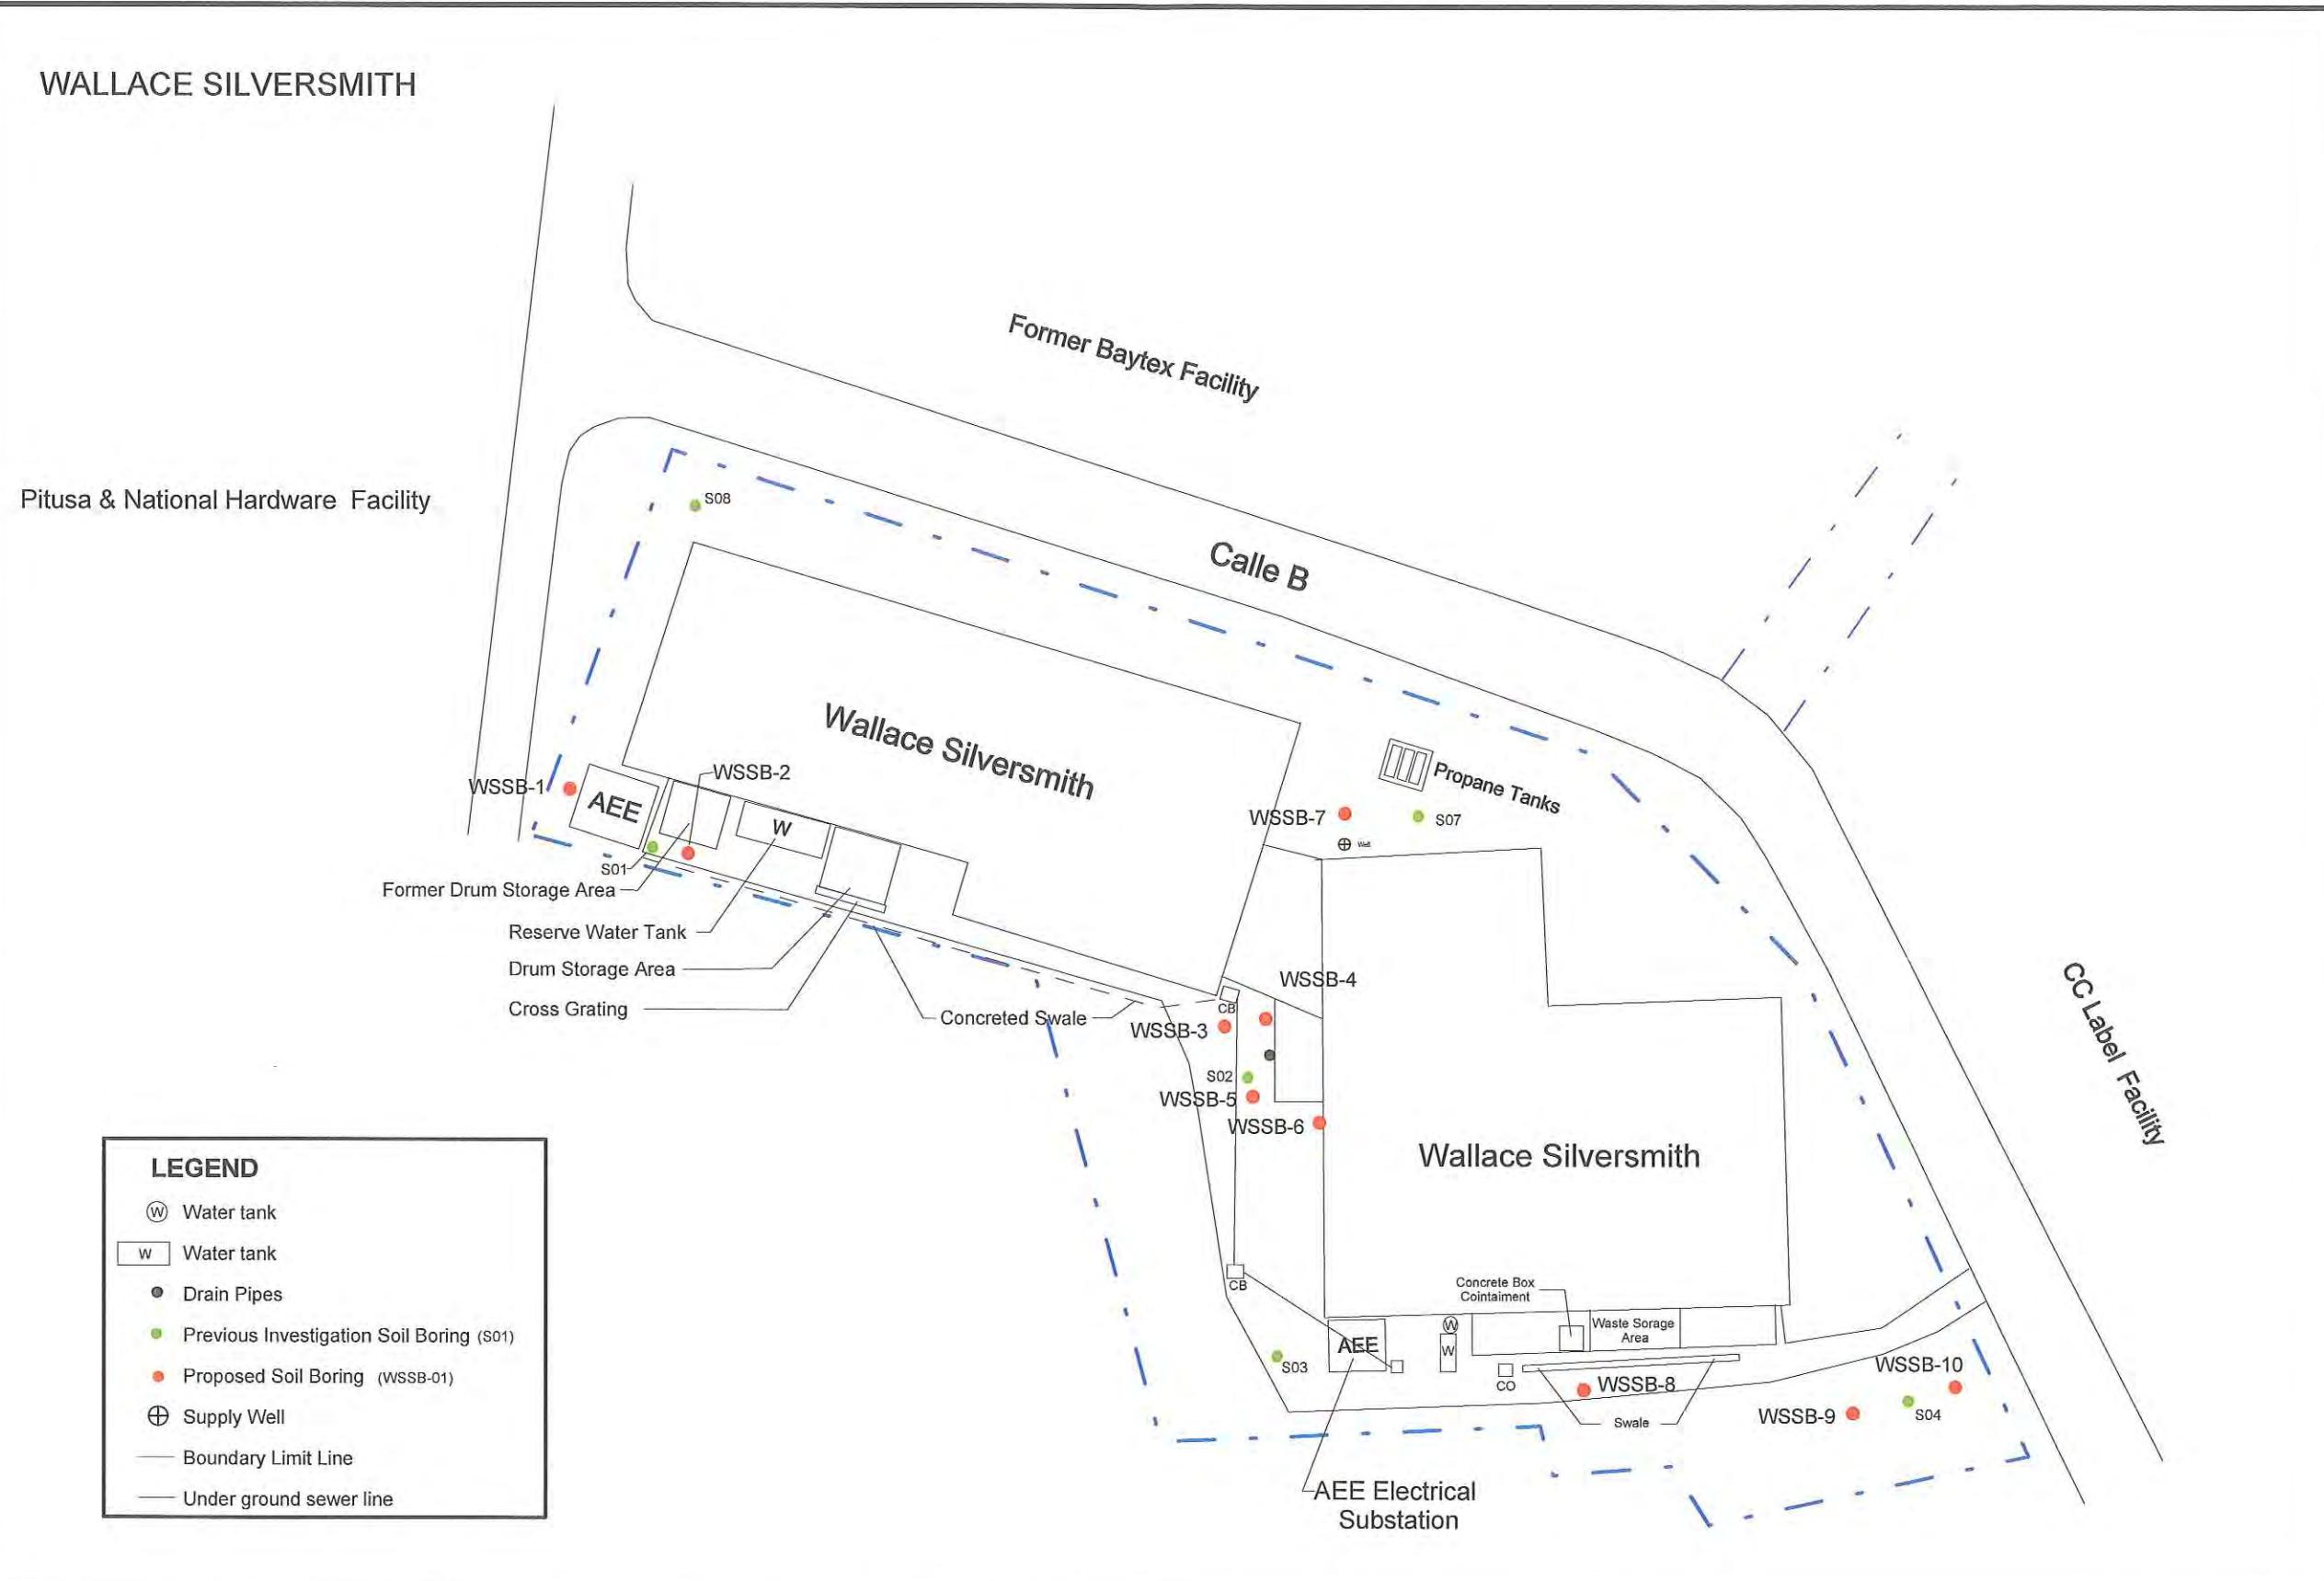
Floor drains observed included one approximately one-inch diameter drain in the process area which was closed around 2002 by covering/filling it with cement.

1. 600-gallon concrete UST which receives water and cement from the sink.
2. 3000-gallon AST
3. 500-gallon AST
4. 300-gallon ASTVibratory tank situated opposite water tanks and west of culvert, which contains residue (paste) characterized as non-hazardous

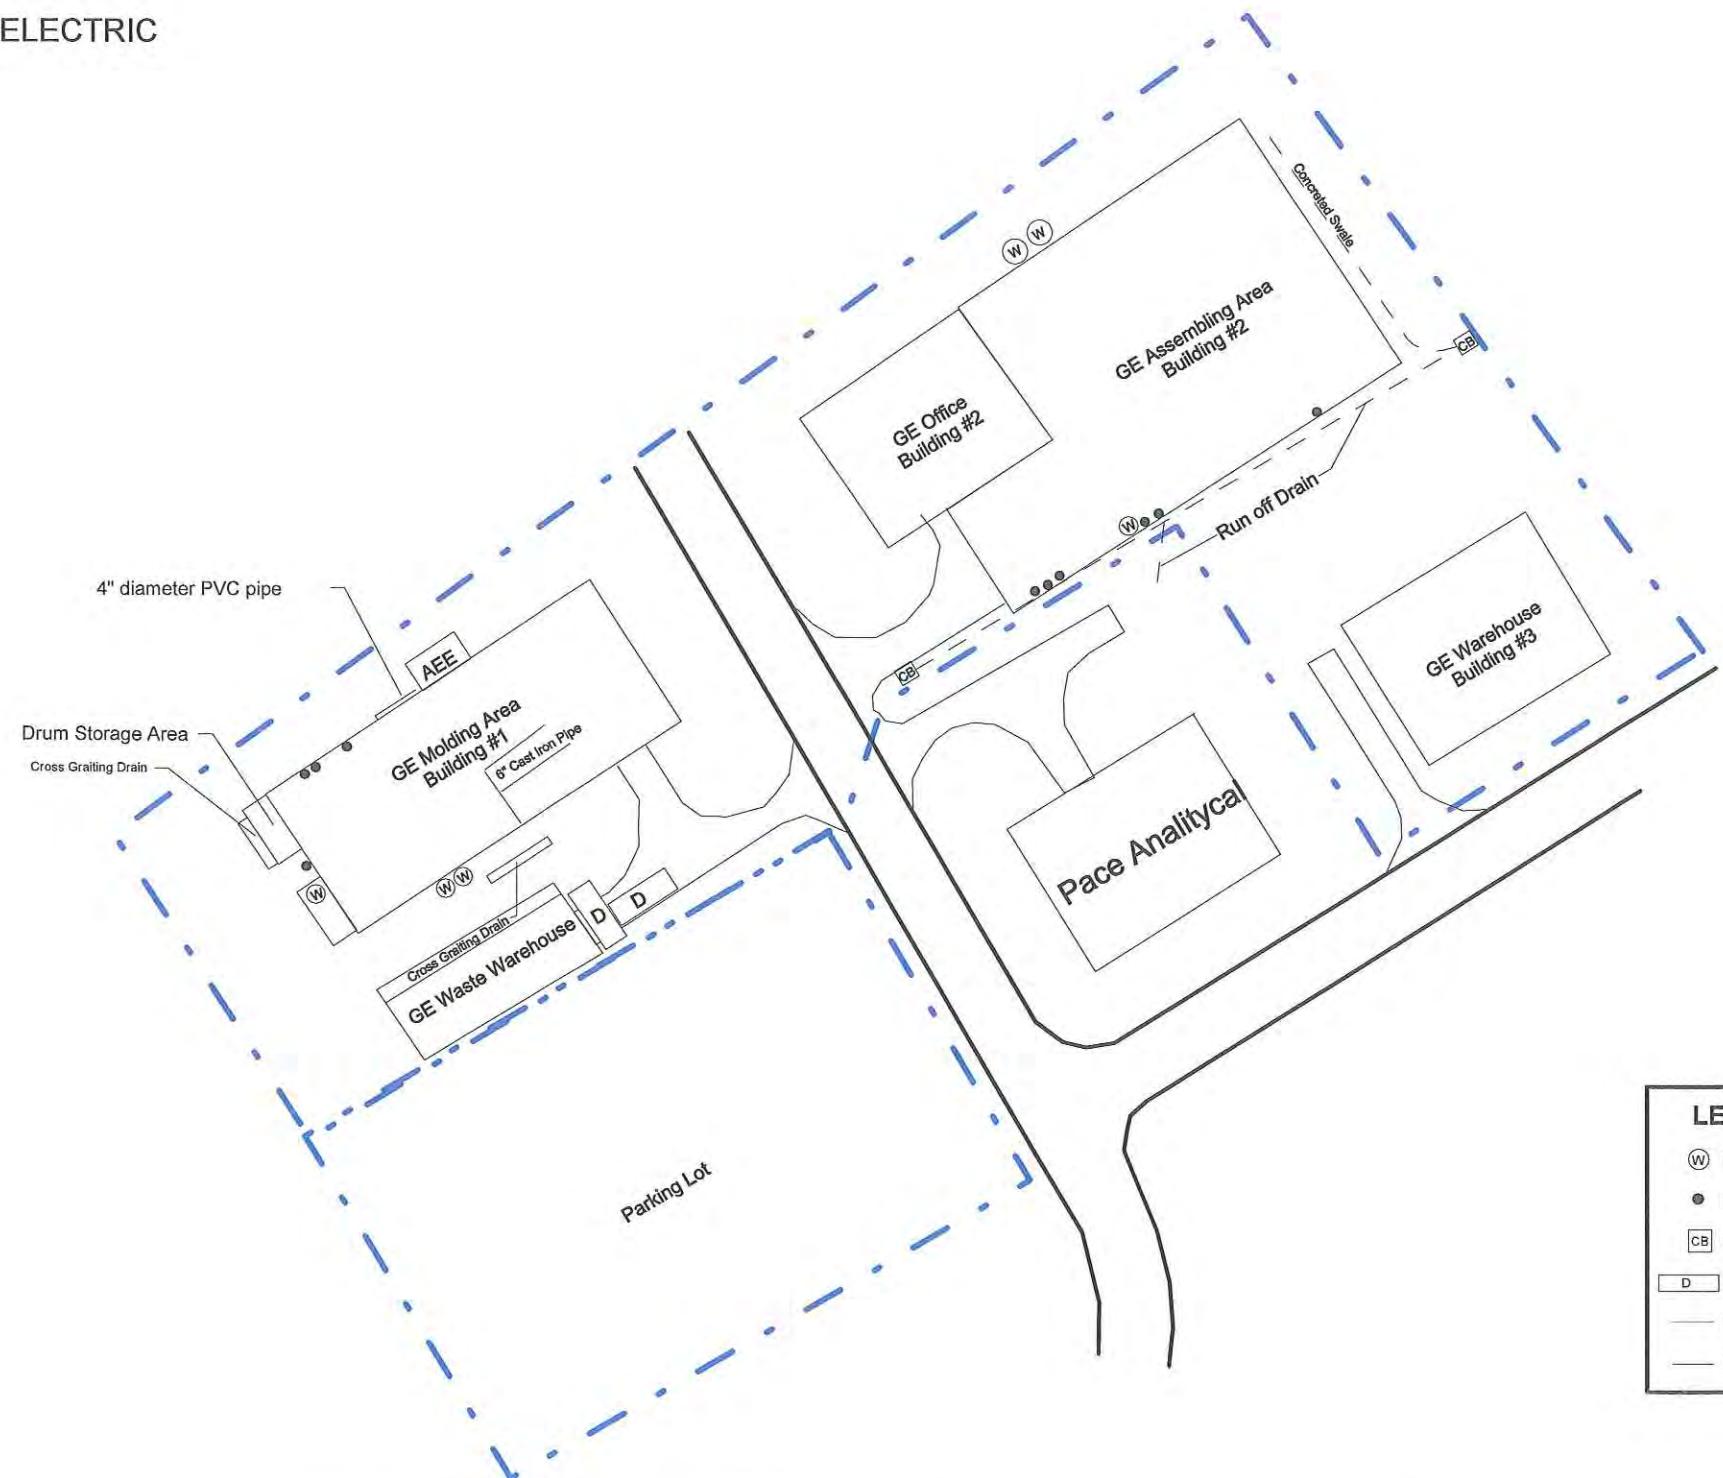
Figure 6
PSA Inspections GE Layout
San German Groundwater Contamination Site
San German, Puerto Rico

At Building # 1 a trench drain with a 2-inch diameter pipe was observed running along the floor. The drain exits to the exterior of the building and is not used. The purpose and past use of the drain is unknown. A small drain about 2 inches in diameter and covered w/cement was also observed in Building #1.

Two 10,000 gallon diesel ASTs are onsite in the parking lot of Building #1. Four 300-gallon water ASTs are present onsite and used as backup in case water service is cut.

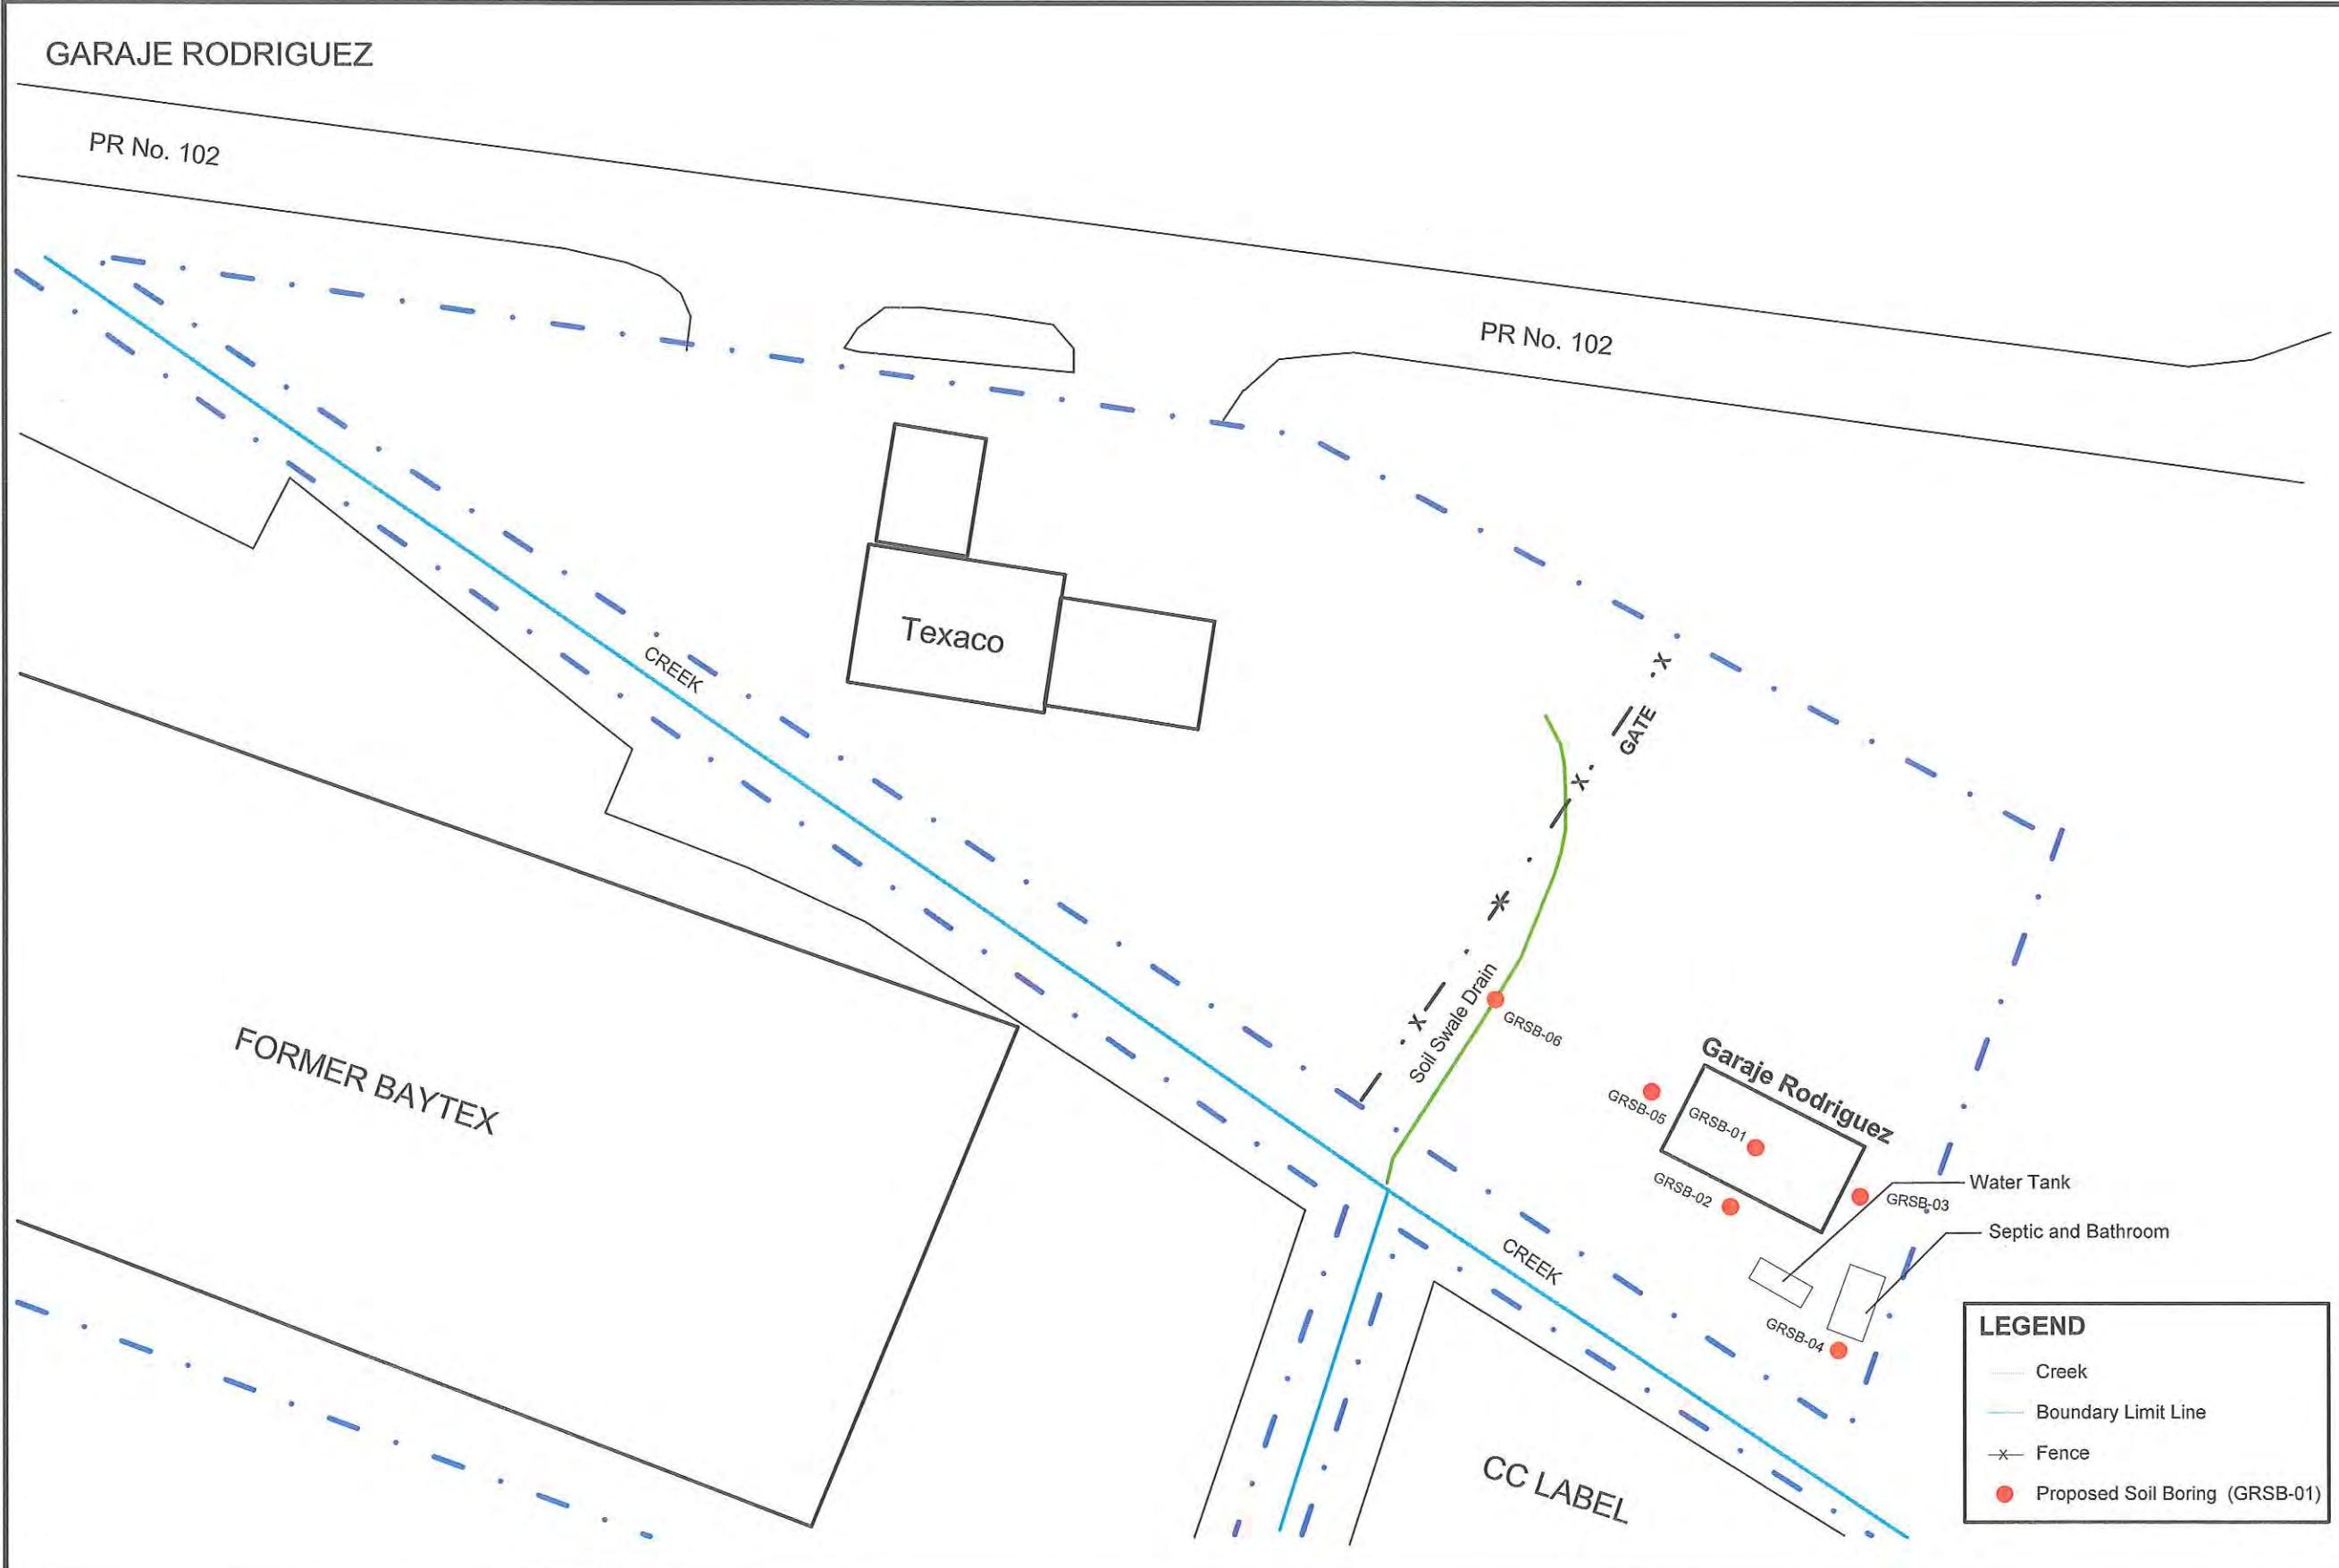
Figure 7
PSA Inspections Garaje Rodriguez Layout
San German Groundwater Contamination Site
San German, Puerto Rico

Mr. Rodriguez has a shop of 20 x 20 feet in size, with a concrete floor, where he repairs and paints cars. A bathroom inside a small shack with a bathroom inside was observed separate from the main shop. Water for the bathroom is supplied by a 55-gallon drum. Waste is collected in a septic tank located below the bathroom. The bathroom and septic tank are located very close to the creek. Mr. Rodriguez said that he does not generate much waste; the most common waste being the newspaper and strapping tape for covering the car before painting. Mr. Rodriguez cleans the pressure paint gun by adding thinner to it and spraying it on the inside of a drum until the paint gun is clean. Some spillage to the ground may occur during this process. Any additives or residual paint are poured into a drum. He lets the residual evaporate or dry so he does not disposed of any waste.

No drains were observed. The bathroom sink drains through the septic system.

A 200 gallon above ground tank that stores water was observed.

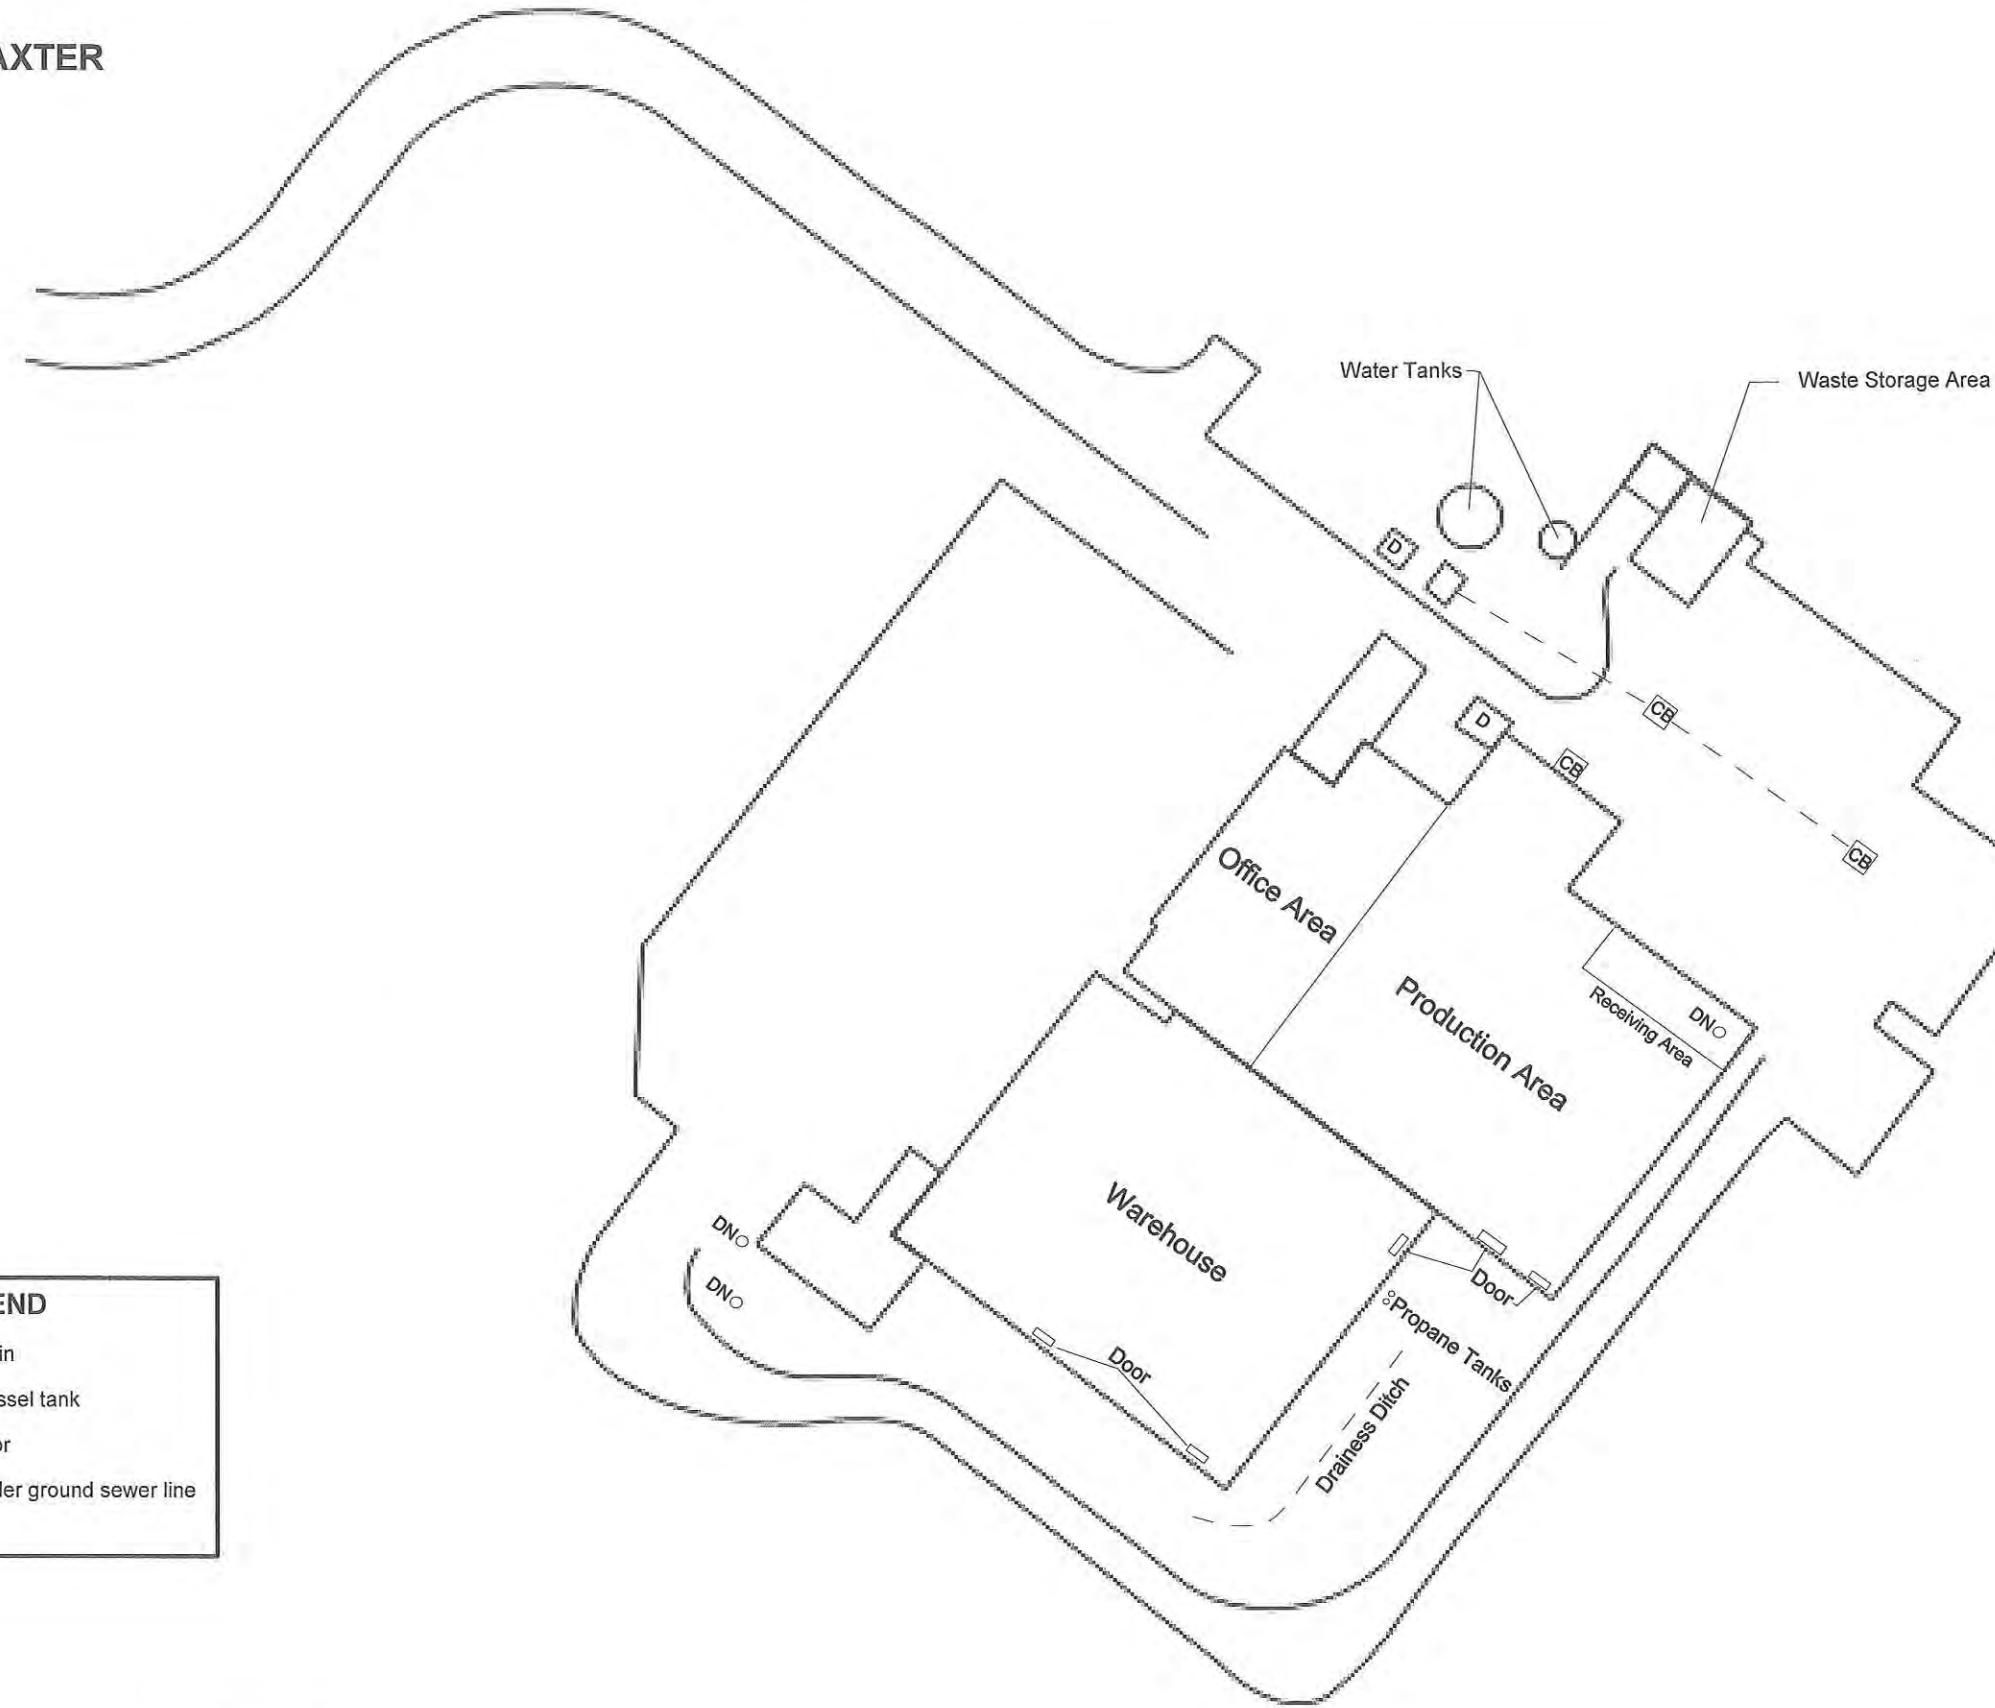
Figure 9
PSA Inspections Fenwal Baxter Layout
San German Groundwater Contamination Site
San German, Puerto Rico

tile. Flooring in the warehouse is in polished concrete. J. Reyes observed a drain at the loading dock of the receiving area which points as a drain for washing that area. No information was available as to where the drain connects. It is assumed to connect to the sewer drain line.

One two-inch diameter drain was observed at the receiving loading dock area. The drain's purpose is unknown and is assumed to be connected to the sewer line of the facility.

ASTs: Two above ground storage tanks of 6,000 gallons and 3,000 gallons contain diesel. Two above ground storage tanks of 40, 000 gallons and 250 gallons contain water and are used for backup in case PRASA shuts down the services.
